Maryland Historical Trust HISTORIC PROPERTIES
State Historic Sites Inventory Form

1. Nam	e (indicate pro	eferred name)		
historic	418 West F	ranklin Street		
and/or common	McCormick	Paints		
2. Loca	ition			
street & number	418 W. Fra	anklin Street	_	not for publication
city, town	Baltimore	vicinity of	congressional district	Seventh
state	Maryland	county	Baltimore

Survey No. B-4415

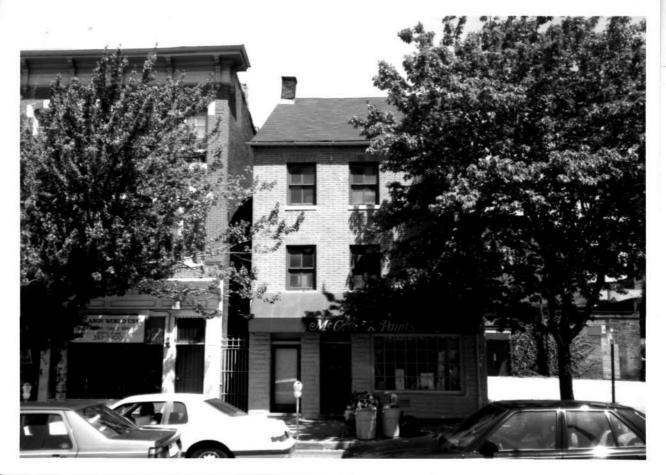
This circa 1830 house is a three-story, three-bay, gable-roofed building facing south on West Franklin Street. It abuts a partywall structure to the west and an empty parking lot to the east. The street frontage is 25- and the depth is 94'9".

The first story has been altered into four bays and is covered with circa 1960s formstone. The first bay contains a glazed door with a blocked transom. The second bay contains a glazed door with a blocked transom; this door opens into the commercial first story. The third and fourth bays contain a large 28-light display window. An awning is suspended over the first story.

The second and third stories are laid in brick flemish bond. The windows are 2/2 sash with brick splayed jack lintels and stone sills.

The brick dentil cornice has an alternating pattern of projecting and recessed headers. The gable roof has chimney stacks rising above the west wall.

B-4415 418 W. Franklin St Baltimore MD Drane Shaw Maryland SHPO Facade, South elevation 1/2
